# **PLASTERING AND DRY LINING**

**Building Construction III**

# Procedure for plastering

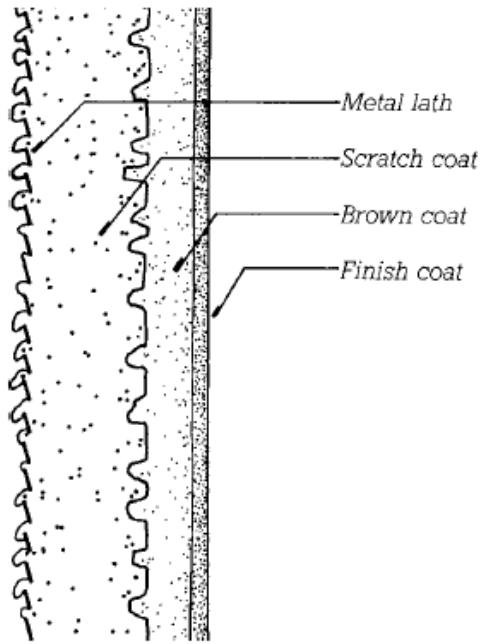
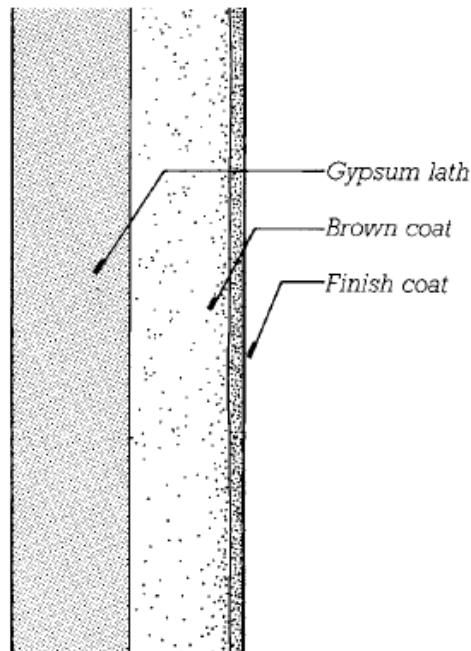
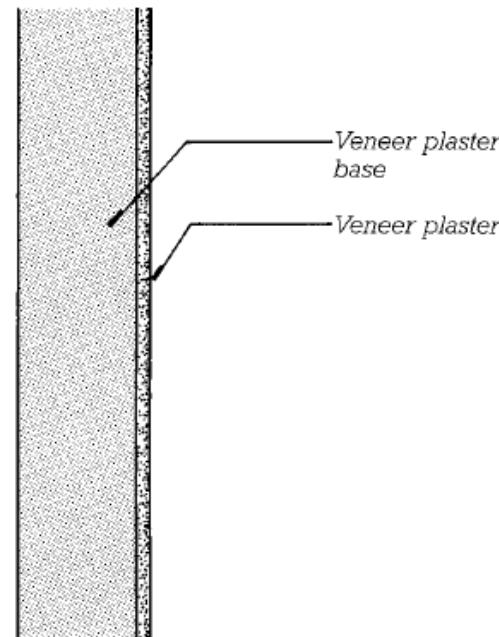
**Sections through the three common lath-and-plaster systems.**

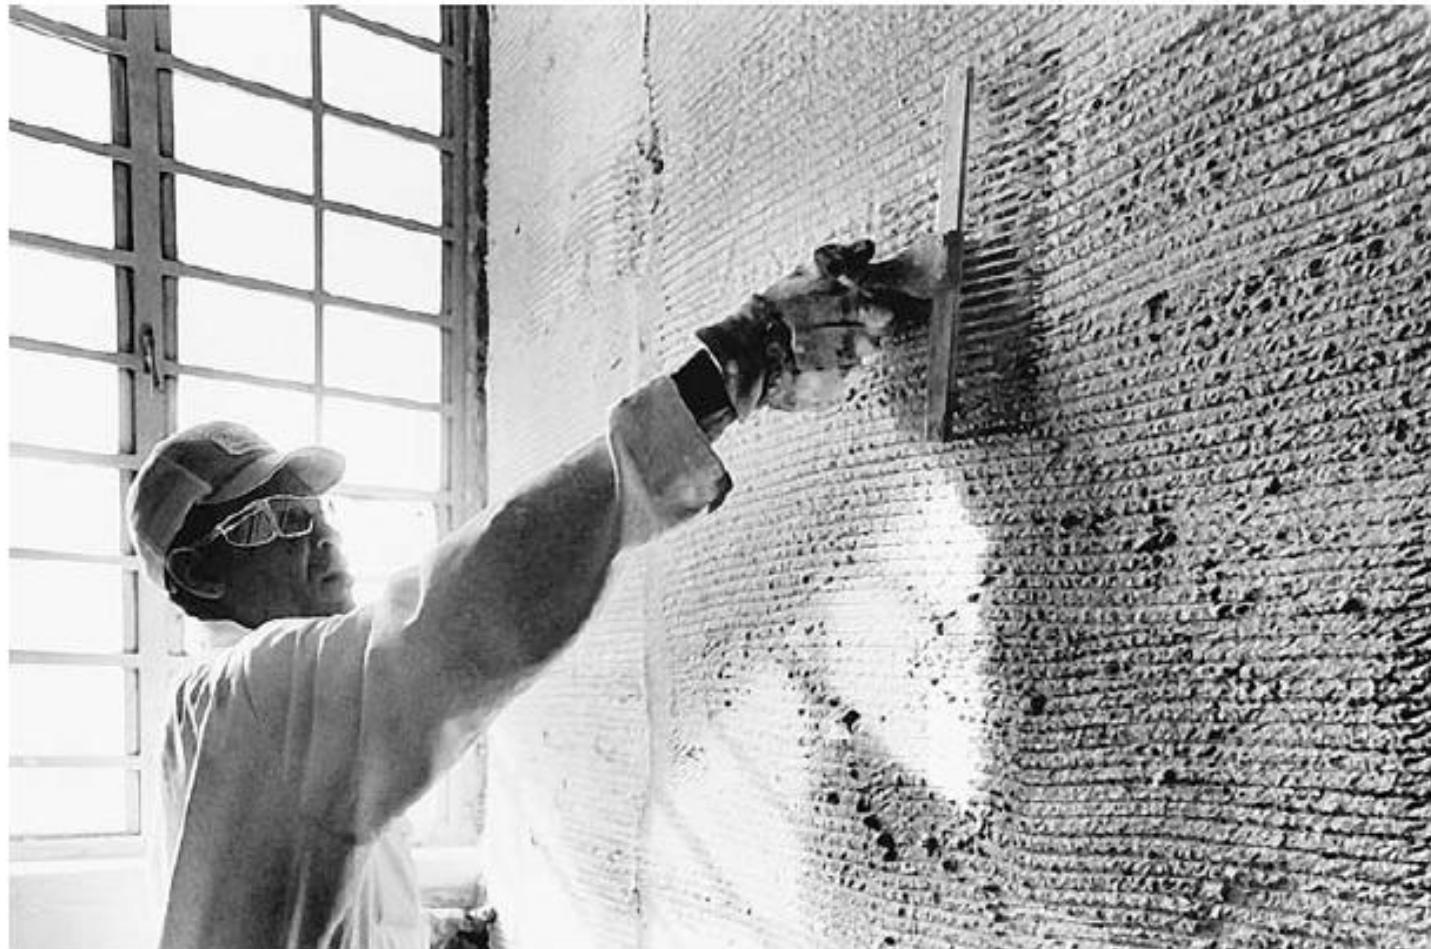
**Scratching the scratch coat while it is still soft to create a better bond to the brown**
